SITE AND BUILDING INSPECTION SUMMARY

School: Lake Mills High School

Lake Mills School District Facilities Study Building Inspection Report – High School

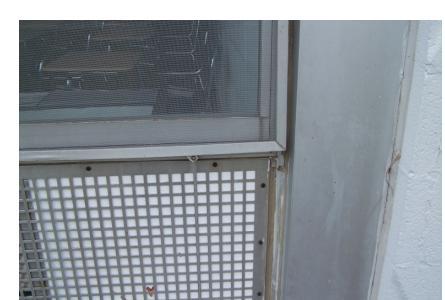
Window fit and condition

- a. Expected Life span 25-30 years
- b. Current Condition: Good/Fair/Poor depending on location.
- c. Window condition varies around the building.
- *d.* Most are insulated units. But older windows are showing greater signs of wear with deteriorating seals and poor fit.

- Consider replacing windows that are not operating correctly.
- Replace all seals and gaskets on windows.
- Replace windows that have rusted frames.
- 2. Roof
 - a. Expected life span 20 years for rubber EPDM, 30 years for Thermoplastic, 40 years for built-up asphalt systems
 - b. Current Condition refer to Roofing Chart for installation and replacement schedule.
 - c. All roofs inspected and repaired annually by Facility staff.
 - d. Roof composition undetermined.
 - e. Scuppers appear in good condition and drain at splash blocks at grade where applicable.

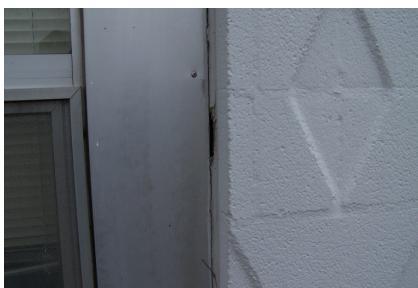
Replace sealant in older windows

- h. No flashing at head or sill in some locations.
- i. Gaskets and weather stripping in the older windows is deteriorating.
- j. Sealant needs to be replaced in select locations.

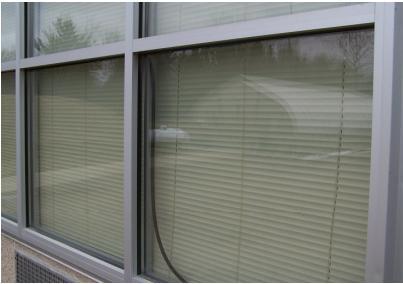
Weather stripping to be replaced

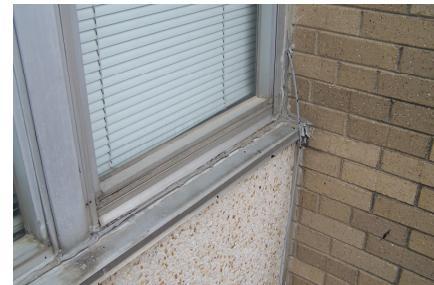
Weather strips and gaskets

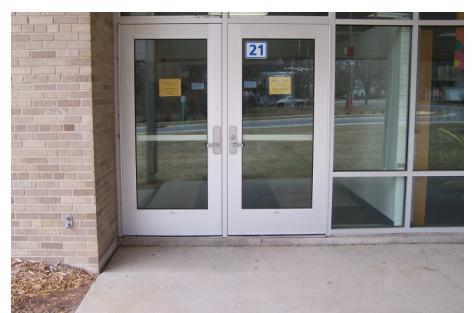
Slab settling at exterior doors

- Monitor the condition of the steel doors for deterioration and maintain as required.
- Replace stoops with scheduled site work.

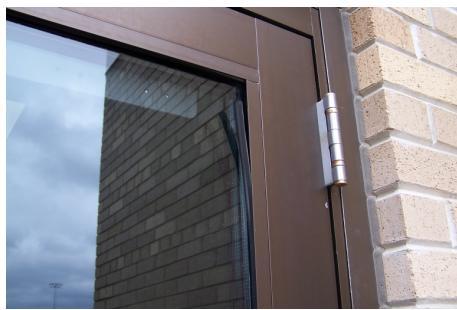
Loose Weather Stripping

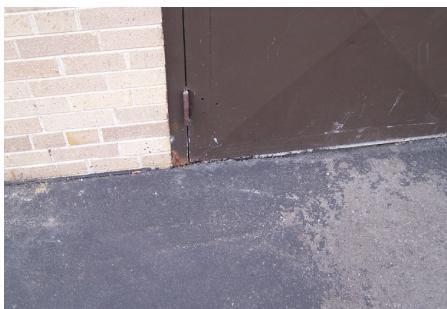
Rust on North door frames

- a. Expected life span 20 years for steel, 30 years for aluminum/FRP systems.
- b. Current Condition good/fair
- c. Steel door and frame at service and entry areas. Bottom edges of the door frames showing slight deterioration.
- d. Insulated glass with double panes in all steel doors.
- e. Some paint peeling on steel door frames.
- f. Stoop/slab settling at exit doors.
- g. Steel doors with single pane glazing at West main entry of the original 1960 building. Deterioration of the frames at grade.

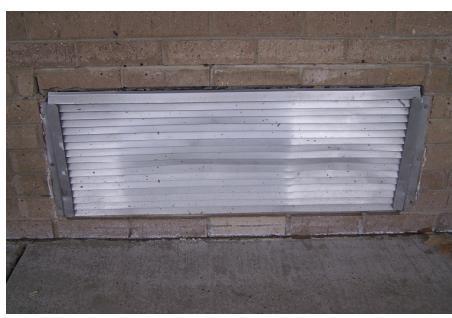
Wall condition at some openings

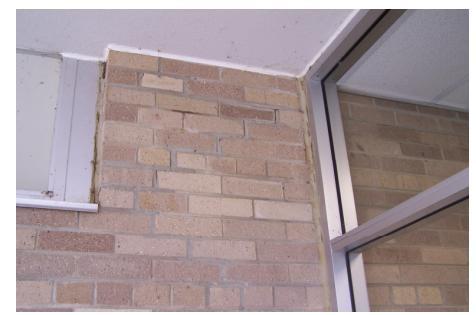
- c. Current Condition: Masonry is in good condition. Some tuck pointing required.
- d. Wood vertical siding Fair/Poor. Nearing end of material life expectancy.

Tuck Pointing areas

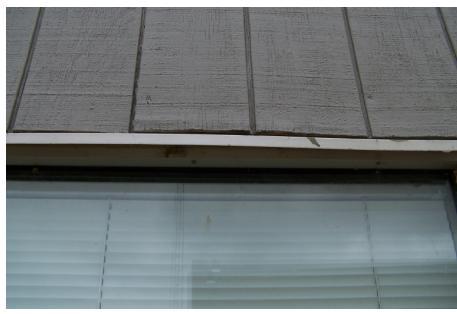
Wood siding condition

- n. Wood siding above windows generally in Fair/Poor condition, weathered. Some degeneration.
- o. Some areas where the flashing wraps up the adjacent wall there is degraded sealant,
- p. Generally all joints between wood siding and adjacent materials are open or in poor condition.
- q. Paint peeling on the original 1962 block building.
- r. Metal wall damaged on the link to the Tech Ed building.
- s. Some cracking on the precast concrete walls of the Tech Building.

- Remove rust from steel lintels and paint with high quality enamel.
- Remove and replace all degraded sealant and replace with new.
- Consider replacing all wood siding with an appropriate replacement exterior material. If a wood grain appearance is desired consider cement board siding.
- Strip and paint all peeling areas around the building.
- Tuck Point all masonry areas as needed.
- Tuck point the cmu on the Original 1962 Building.
- Consider cutting an aluminum cap on the 1988 gym piers. The exposed brick in this area will continue to degrade.
- Consider replacing the damaged metal panel on the link to the Tech Building.
- Repair the cracking concrete panels on the Tech Building as needed.
- Re-caulk joints as required.
- Continue routine maintenance.

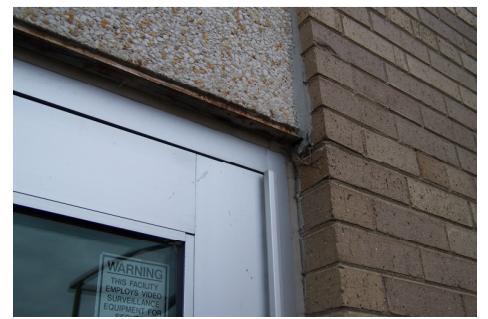
Rust on lintels

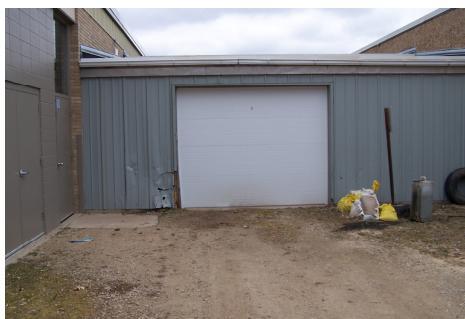
Siding condition/damage at Tech Link

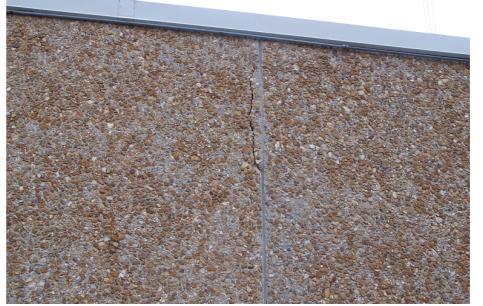
Concrete panel condition

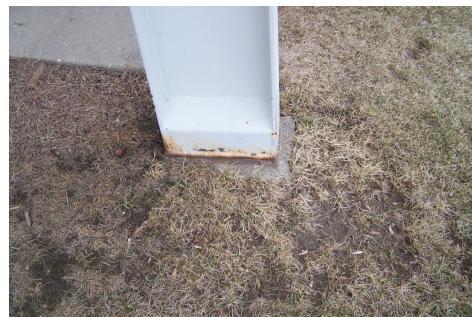
Concrete Column rust

- Remove all peeling paint on fascia sections and repaint with high quality paint.
- Remove all rust on the 1962 canopy and I beam columns and repaint with high quality paint.
- Repair coping and fascia as required.
- Maintain as required.

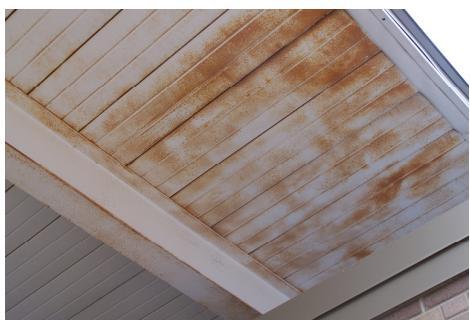
Rust on underside of canopy

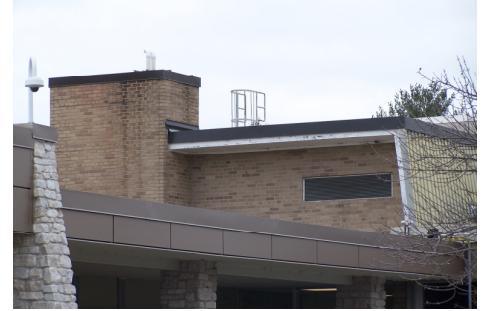
Fascia Rust

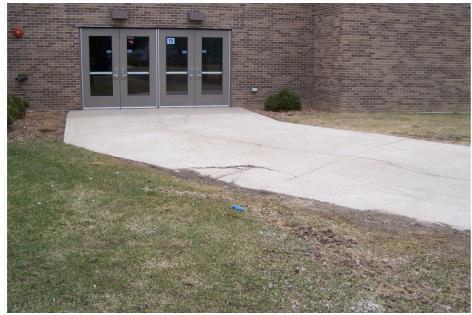
Cracked and settled concrete

- j. Concrete walks leading up to the 1962 building and at the Auditorium have cracked and settled unevenly.
- k. The lid on the abandoned electrical vault on the North side of the building is failing and settling.

- Replace the South parking lot with new asphalt. Areas of land fill that are unstable should be avoided.
- Grade landscape areas away from the building.
- Repair, clean and paint the railings on the East side of the Auditorium.
- Replace the railings on the North side of the building.
- Repair and replace the vault lid.
- As the asphalt and concrete is replaced outside the egress doors, the slope will need to be ADA compliant.

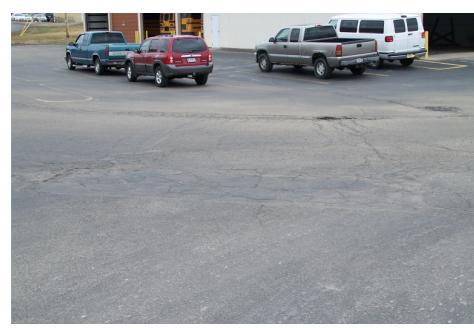
Asphalt condition at bus barn

- g. Asphalt in the parking lot next to the bus garage in poor condition showing general cracking and alligator cracking which is a sign of poor subsurface failure, repeated over loading and poor drainage. Ponding water in these areas will continue to deteriorate the asphalt.

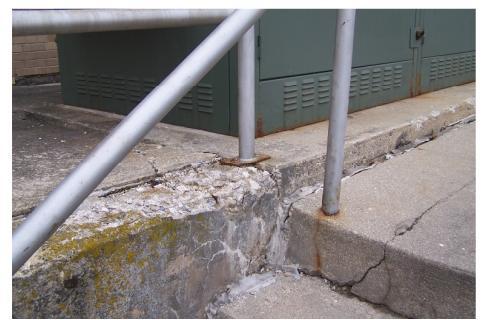
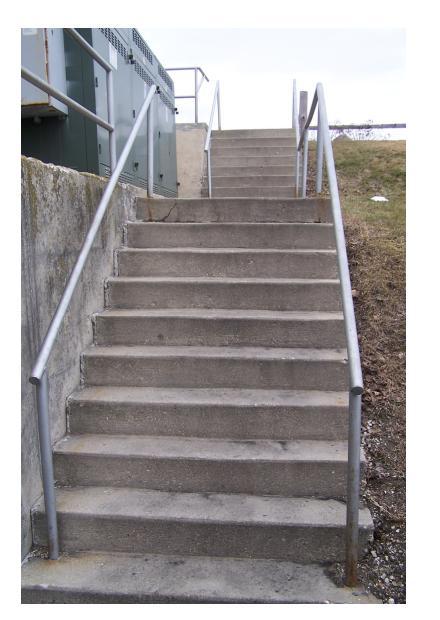
- I. Exterior railing on the North side of building adjacent to the generator is failing. The concrete steps are deteriorating and some railing supports are no longer anchored into the steps.

Stair condition at North site stair

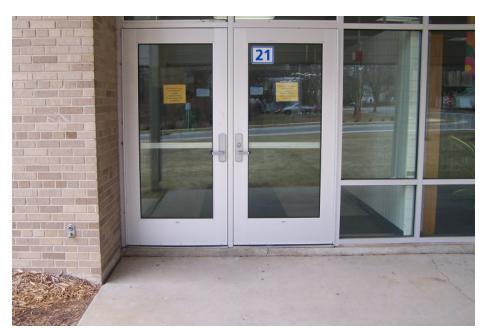
- d. Some concrete areas are cracked but no settling seen.
- e. Stoops outside the exit doors of the gym and 1962 building are not ADA.
- f. Asphalt south of the Auditorium area aged and at the end of its service life.

Lip at exit doors similar at the 1988 Gym addition. Not ADA.

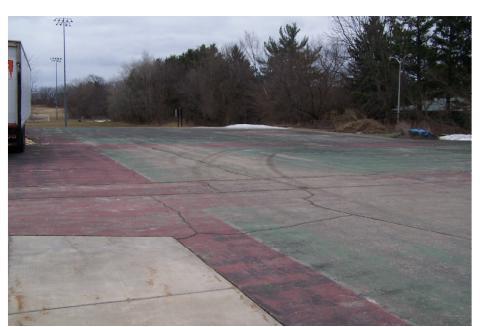
Asphalt condition at South Lot

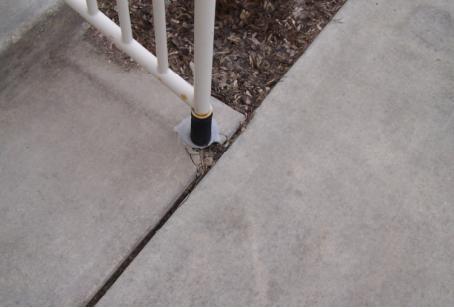
Stair to East of Auditorium

- m. Railing on the East side of the Auditorium is showing signs of deterioration.

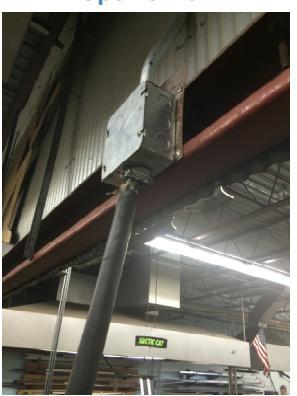
- No master emergency shut off was provided on the Tech Ed panels. We would recommend an emergency shut off with a contactor to shut down all shop equipment if the emergency switch was activated.
- We noted open wiring in the tech areas. This should be routed in conduit and properly supported.
- All shop equipment in Tech Ed labs should be equipped with a magnetic starter. This provides protection in the event of a power fail the equipment will not start back up after power is restored.
- We observed miscellaneous junction boxes that should be covered.

Exposed Wiring
