SITE AND BUILDING INSPECTION SUMMARY

School: Lake Mills High School

Lake Mills School District Facilities Study Building Inspection Report – High School

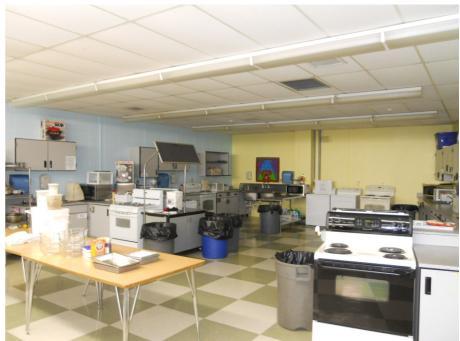
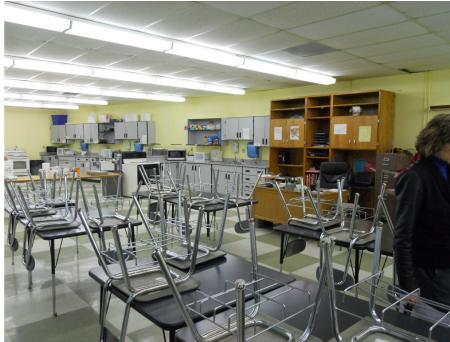
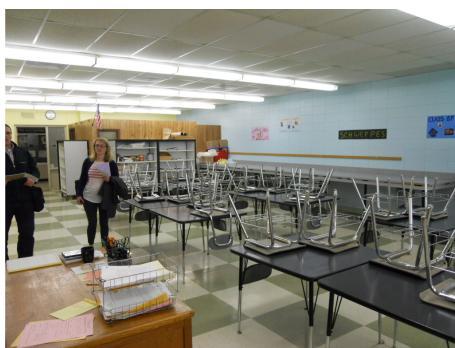
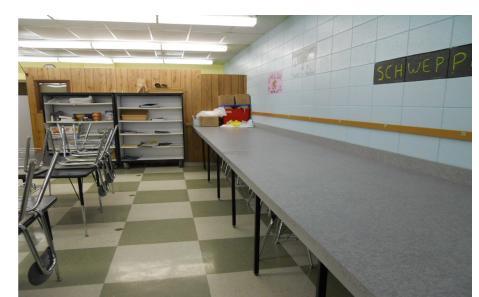
Family and Consumer Education

- Existing Conditions
 - Two Distinctive Subject Areas
 - o Textiles
 - Focused on sewing and quilting with tall storage cabinets
 - o Foods
 - (6) individual kitchenettes in a configuration suited for a Home Economics curriculum
 - One instructor for one large space. Lecture space is on one end and kitchenette instruction on the other.
 - Plastic Laminate counters.
 - Residential curriculum.
 - Space is relatively large
 - Both subjects have limited capacity and demand.
 - Both subjects are hands on yet the two spaces have dedicated lab and lecture areas
 - General Classroom Observations
 - Classroom is flexible and provides opportunities to rearrange the lecture area.

- Students often stand but some districts have provided stools if the stations are also us+ed for lectures.
 - Plan for replacement of laminate countertops with stainless steel for durability and sanitation.

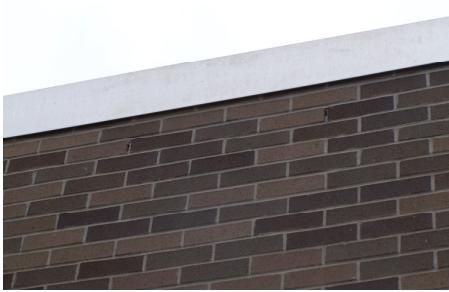
- c. Current Condition: Masonry is in good condition. Some tuck pointing required.
- d. Wood vertical siding Fair/Poor. Nearing end of material life expectancy.

Tuck Pointing on Auditorium

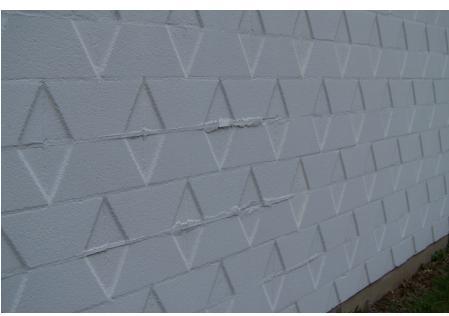
Tuck Pointing at CMU

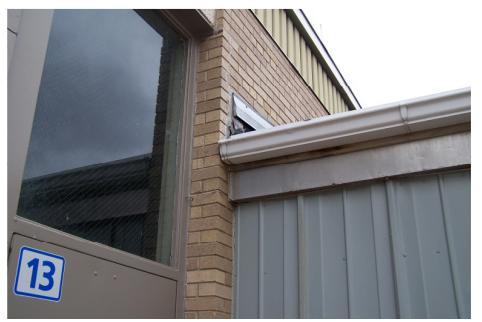
Roof to wall

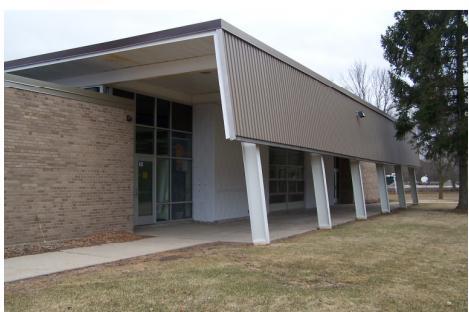
Canopy

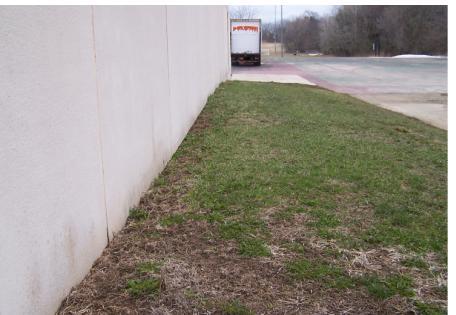
Stair to East of Auditorium

Grade should slope away from building.

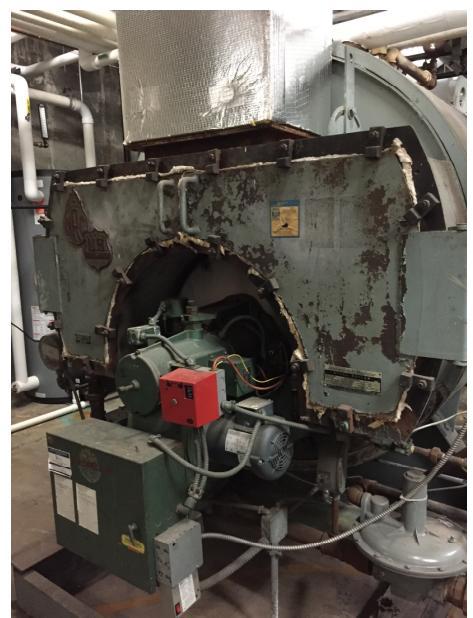
Hot Water Boiler

- The National Boiler is original to the building and is in marginal condition at best. The Aerco boiler is relatively new and was installed to replace a second National Boiler that was removed.
- The current constant flow pumping systems and 3-way mixing valve water temperature control are older methods of boiler plant control and do not take advantage of the high-efficiency capabilities of the Aerco boiler.

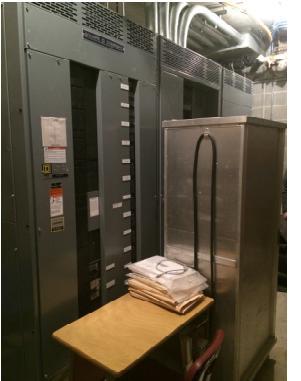
Main Service

1. The Main 2000 Amp service in the facility has capacity for future additions and addition space on the I-line panel is present. The service panel is approximately 4 years old and is in good condition. We do recommend the breakers in the switchboard be exercised each year to ensure they operate properly. This should be done by a licensed electrician and over a pre-planned outage.

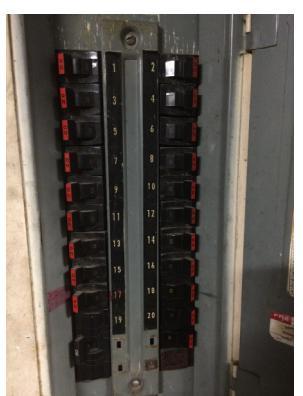
Old panleboard

- Most existing panels have very limited space and are dated to the original construction of the facility. There have been upgrades to some of the panel in the newer addition to new Sq D panels.
- There are approximately 12 existing panels that are over 40 years old and should be scheduled for replacement.

- 1. Keep existing new panels in place add additional circuits if required.
- 2. Replace existing panels over 40 years old with new Panles in place. Breakers over 20 years old can fail as heat, dirt and corrosion over time can cause breakers to not open upon a fault.

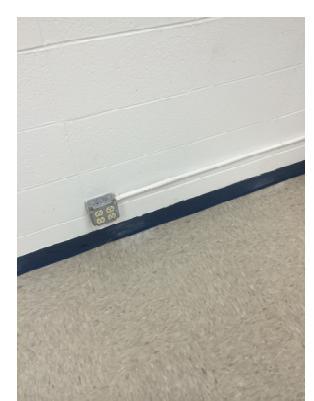
Surface Receptacle

- Three receptacles with one circuit is present in most of the existing classrooms.
- Surface conduit with stamped steel boxes is present in the older classrooms
- Surface raceway with receptacles and low voltage cabling was installed to feed teacher desk location and interactive boards in some rooms.
- We noticed some broken receptacles and faceplates.

- 1. Additional receptacles can be added to existing rooms if required. A typical new classroom in Wisconsin is provided with 9 receptacles and 3 circuits.
- 2. Broken receptacles and plates can be replaced as part of a maintenance program.

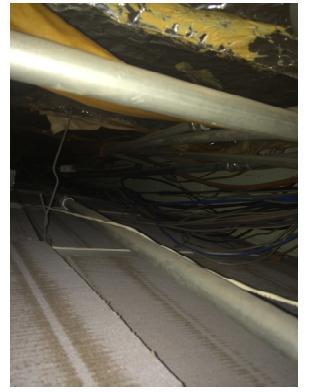
Above ceiling wiring

- The main server for the district is located in the new Middle school facility.
- We observed a lot of cabling above the ceiling not supported and installed untrained over ductwork, piping and light fixtures. This is typical in older facilities and may cause data network issues with speed and connectivity.

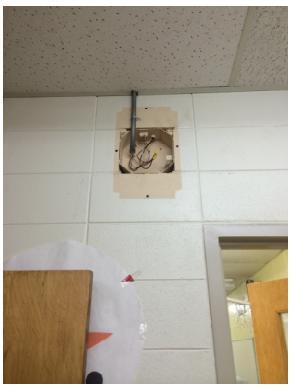
Open J Box

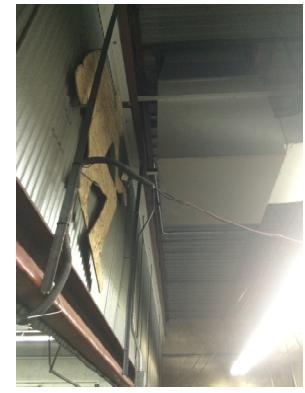
Exposed Wiring

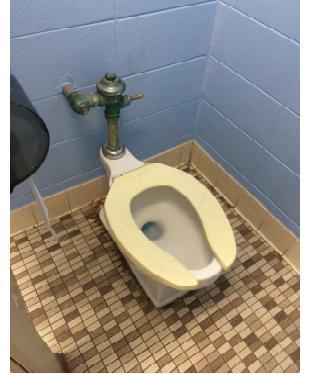
Water closet

- Many of the plumbing fixtures are original to the building and are in poor / fair condition.
- The lavatories are porcelain, wall hung units with manual faucets.

- 1. Schedule the replacement of the existing toilet room fixtures with low flow, ADA compliant fixtures.
- 2. Schedule replacement of any old, non-ADA compliant water coolers with ADA compliant units with bottle-fillers.
- 3. Schedule replacement of the shower pedestals with new low-flow group shower systems and new ADA compliant shower units as required.
